Coastal Engineering Design in the Caribbean

A Case Study –Palisadoes Sea Defences

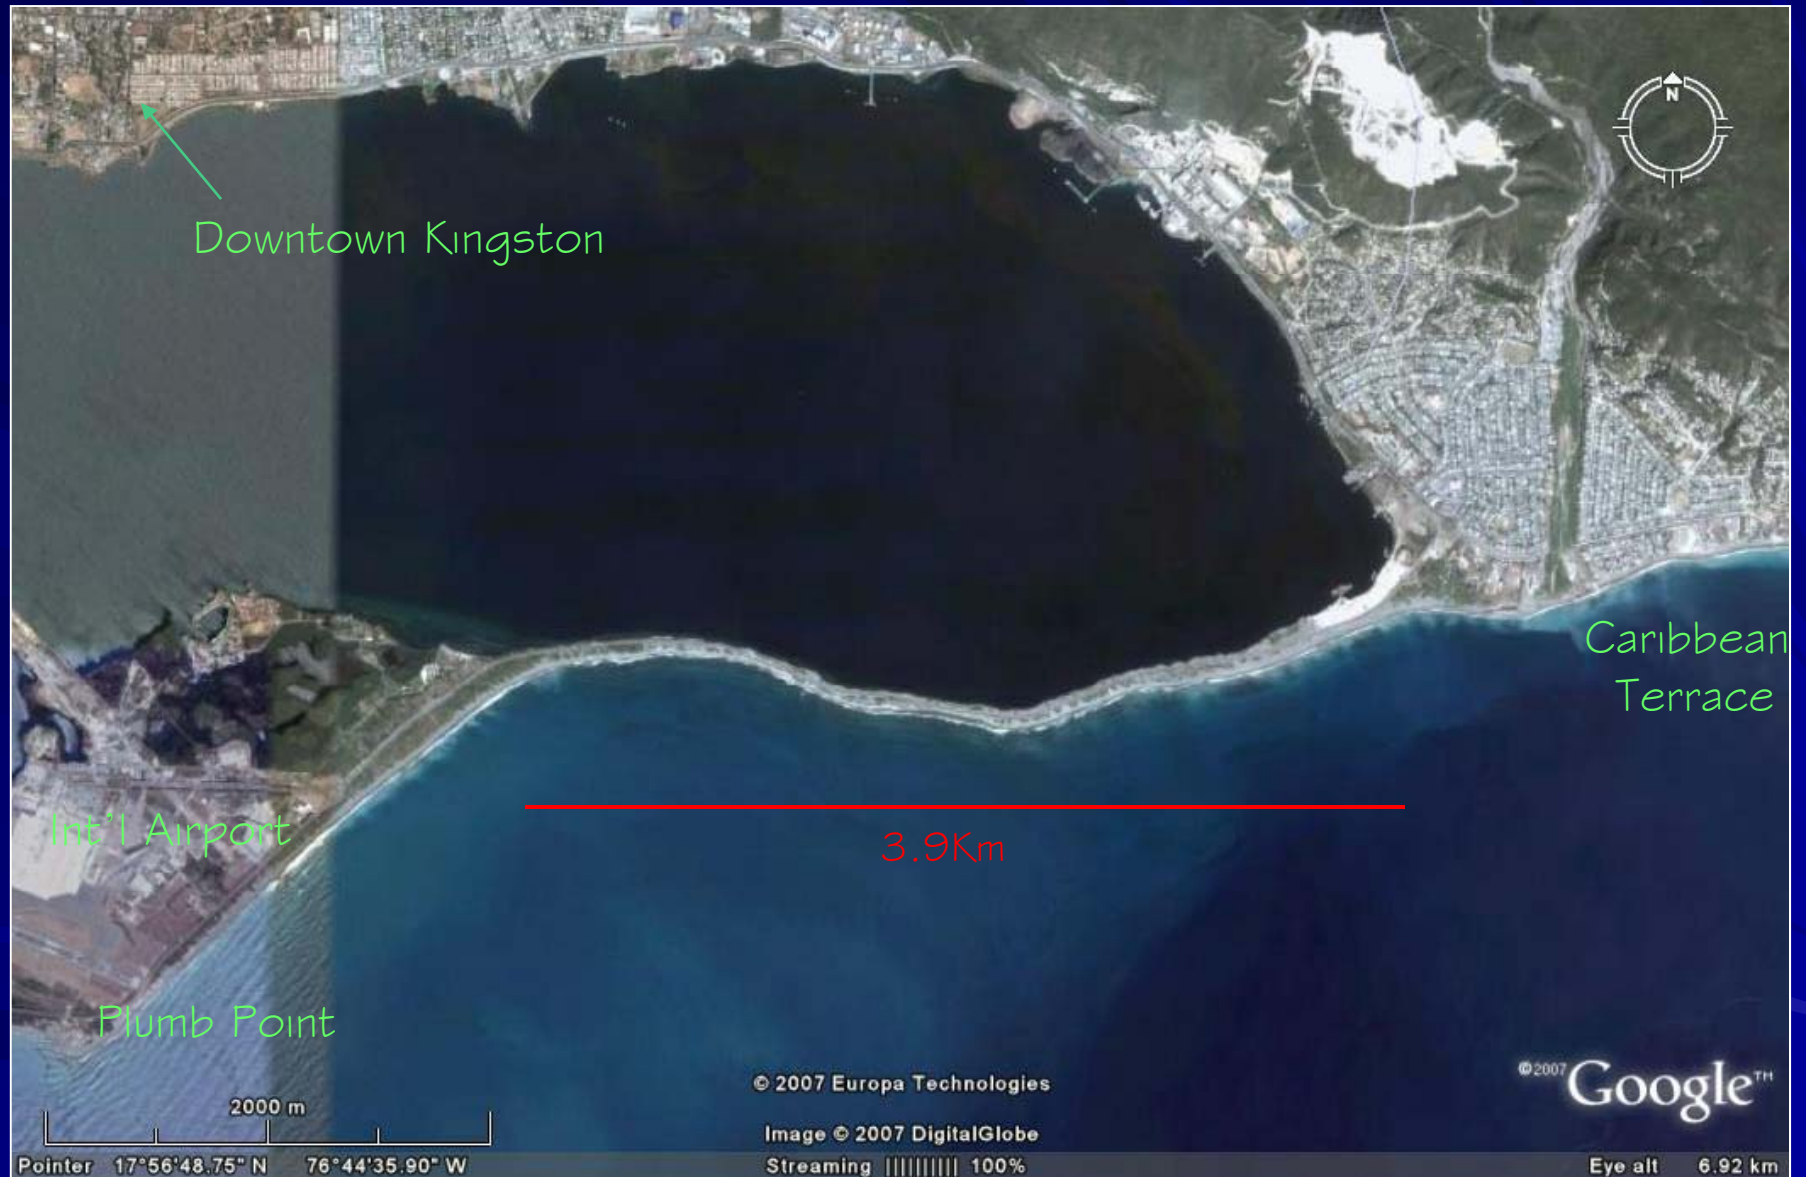
Detail of the Palisadoes strip

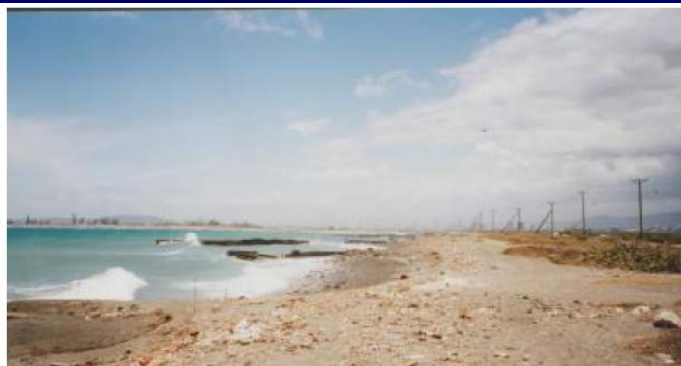
Groyne field -
2002

- Boulders along shoreline and other interventions of unknown date
- After Hurricane Charlie (1951), a groyne field (9 structures) was placed to stabilize 850 m of the most vulnerable section but these deteriorated over the years and ...
 - were damaged by Hurricane Ivan
- A Cuban Team was commissioned to provide a design for Palisadoes sea defenses (1 in 25 year return period)
- Emergency works (1 in 5 year) placed in anticipation of final designs

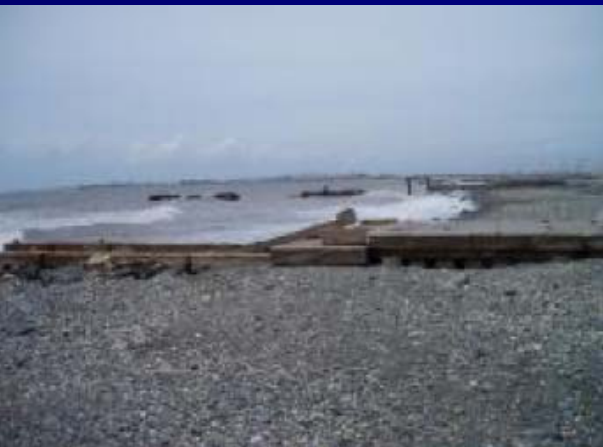
2004,
post-Ivan

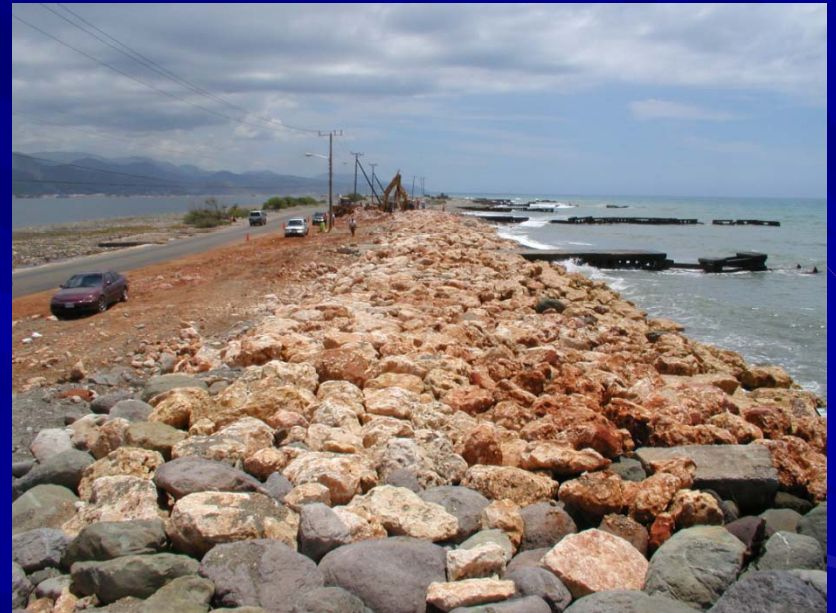
Emergency Works – May 2008

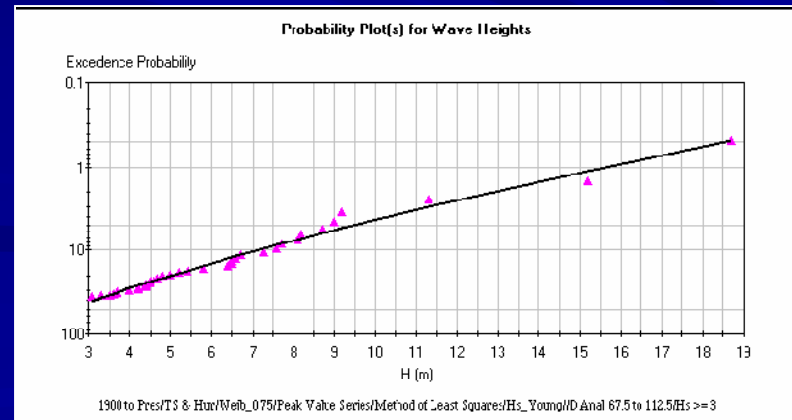
4.2.1 Extreme Wave Climate

- HurWave (in-house program)
 - scans NHC database for storms within specified distance of site
 - Parametric models are used to calculate wave properties
 - Statistical distribution are fitted to exceedance probability plots
 - Return period waves are retrieved
- Wave conditions are described in terms of return periods (average time period between successive occurrences of an event being equalled or exceeded)
- The greater the return period, the larger the design significant wave height

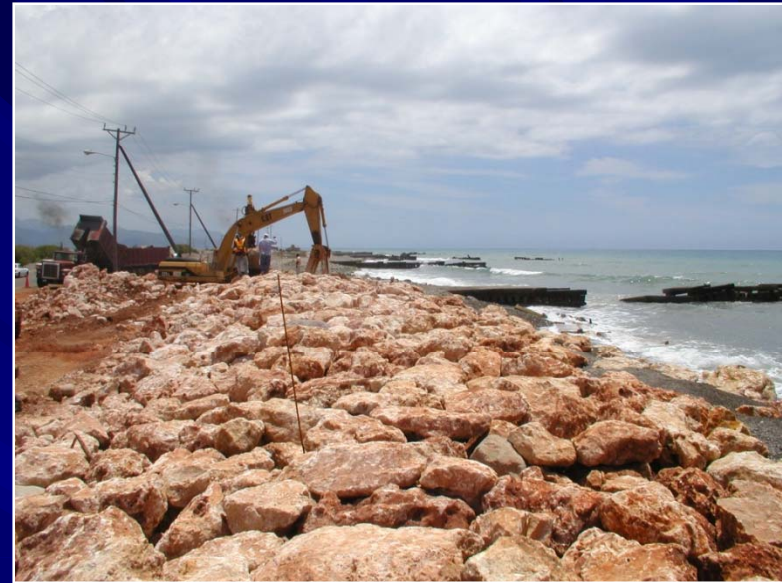
- Following Hurricane Dean, the construction of a revetment was halted in favour of an emergency works programme located along the most critical sector
 - Stones of size 1.4t – Cat 1
- The works could however, serve as the inner core for a final revetment design

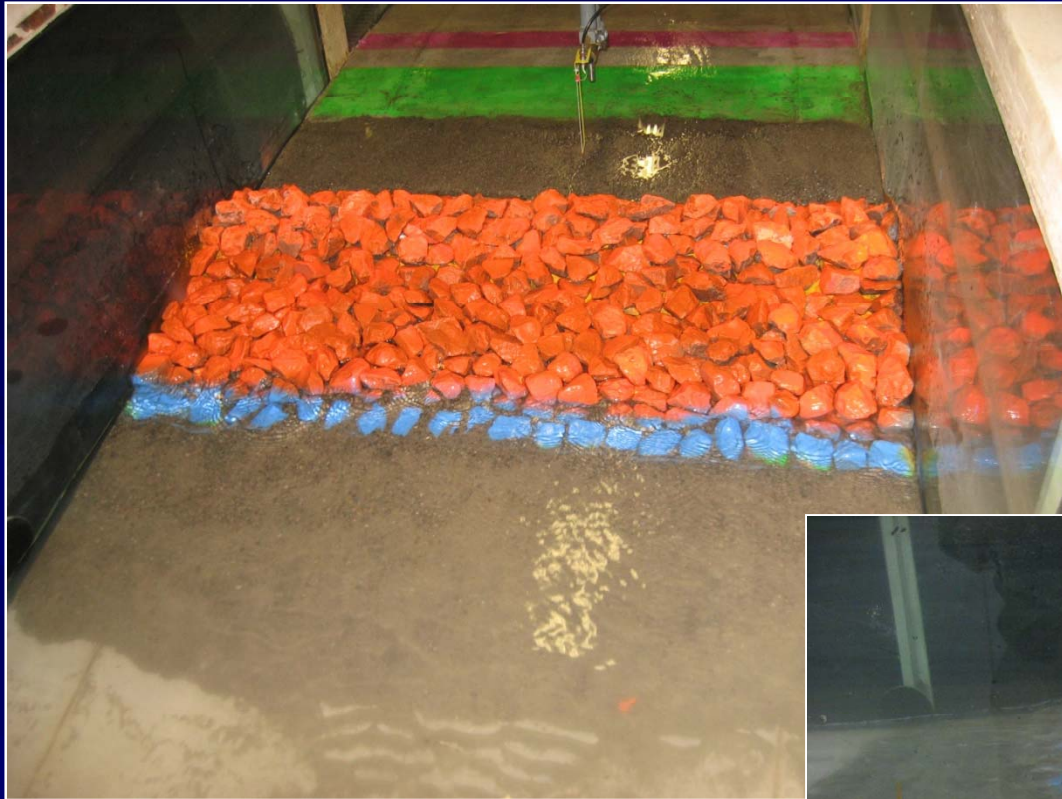
Frontal view of the physical model
For Hurricane Dean.

- A 2-D physical hydraulic model study of the proposed coastal works was tested in the Canadian Hydraulics Centre (CHC – Ottawa).
- The two hurricanes (Dean and Ivan) were used to test the preliminary design.
- In order, to represent the passage of the storms south of Jamaica, the storms were divided into 5 segments of 3 and 6 hours, for Dean and Ivan (100-year storm), respectively.
- A sub-sea profile running from deep-water up to the shoreline at the critical (erosion) sector and following the path of waves through the refraction process was used to extract the relative shoreline slope parameters.
- An appropriate scale for the model was selected, so as to minimise scale effects.

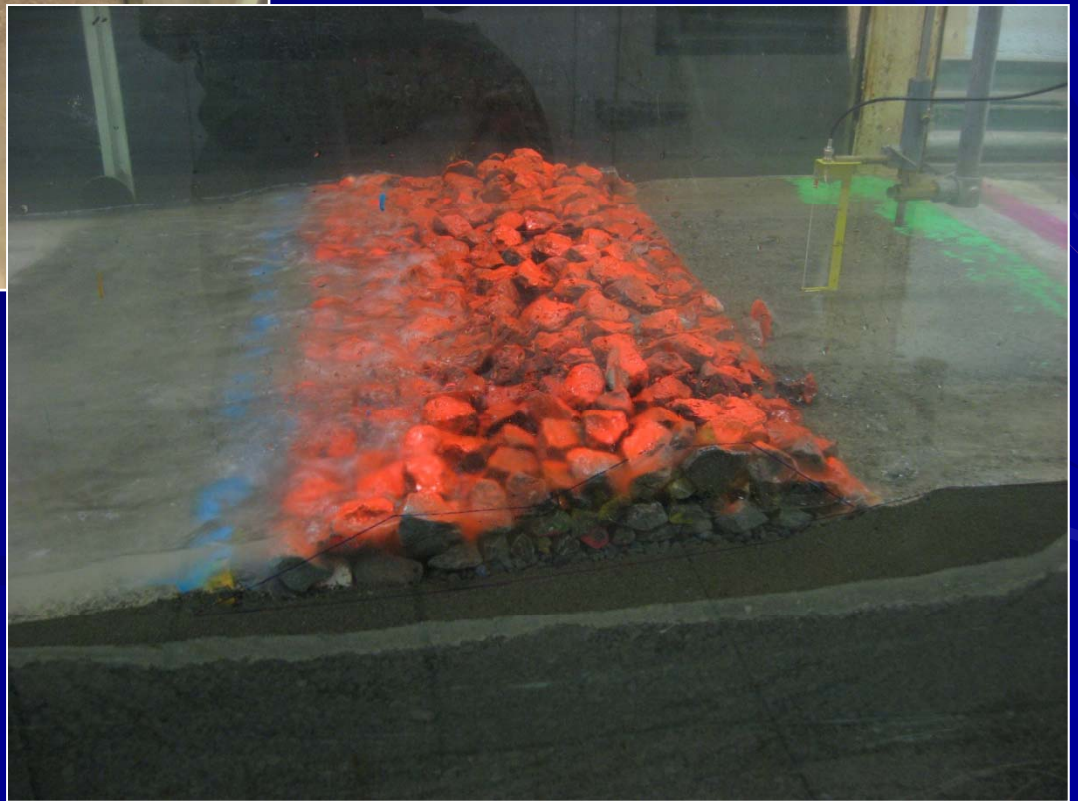
Side view of the physical
model for Hurricane Dean.
